Manhole Inspection Summary

Manhole # S03AA2010MH

Location Address: **6202 WESTERN RUN DR**

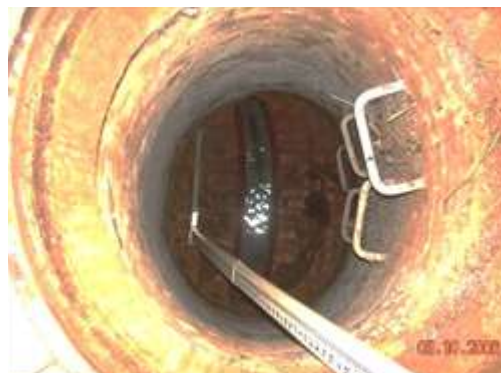
Top View

Frame offset. Adjustment, Corbel and Barrel infiltration. Bench debris.

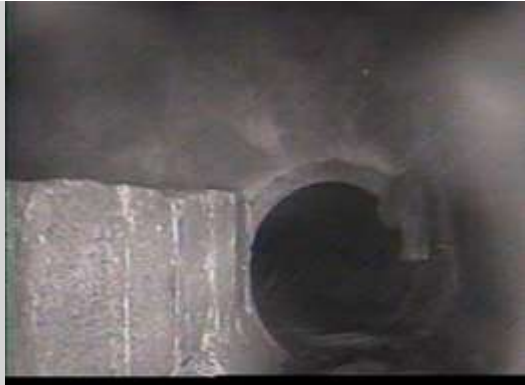
8 in. Circular Gravity Sewer Pipe Out @ 12 O'Clock

Invert Depth: **9.69** (ft.) Flow Characteristics: **Slow**

Deposits: ☒ None ☐ Mud ☐ Sludge ☐ **Debris** ☐ Grease

Infiltration: **Evidence** Pipe Seal Cond: **Unknown**

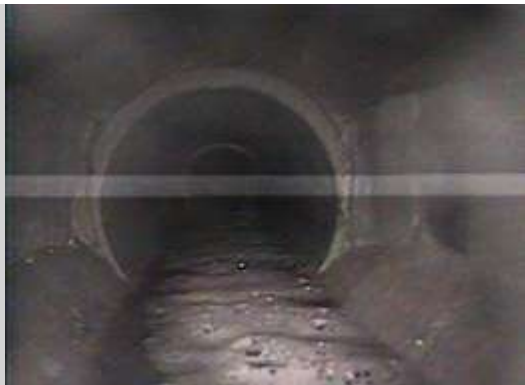
8 in. Circular Gravity Sewer Pipe In @ 7 O'Clock

Invert Depth: **9.65** (ft.) Flow Characteristics: **Slow**

Deposits: ☐ None ☐ Mud ☐ Sludge ☒ **Debris** ☐ Grease

Silt Depth: **1** (in.) Deposits Extent: **Light**
